## **Case Study – GSM2 Comms units**

### **Bentley DSR to Marsh Lane DBS – Level control GSM Comms Link**

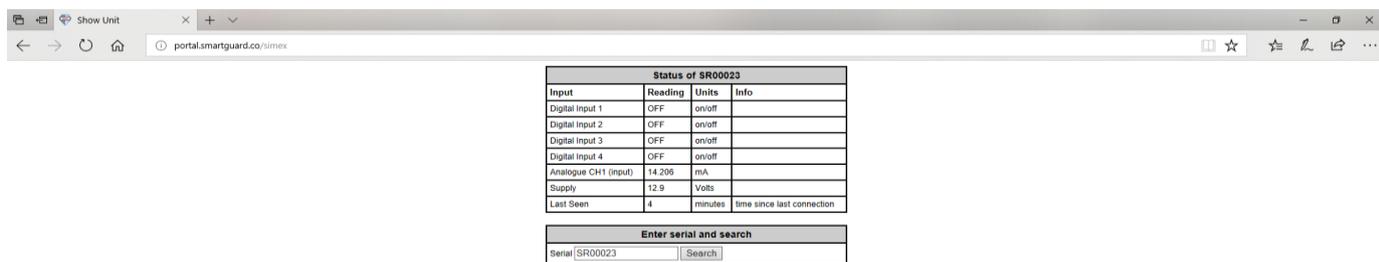
### Free Issue Website/app

Status of SR00023			
Input	Reading	Units	Info
Digital Input 1	OFF	on/off	
Digital Input 2	OFF	on/off	
Digital Input 3	OFF	on/off	
Digital Input 4	OFF	on/off	
Analogue CH1 (input)	14.206	mA	
Supply	12.9	Volts	
Last Seen	4	minutes	time since last connection

Very quickly it was determined that the battery voltage at the DSR (solar panel) end of the comms path had last been seen at 10.2v at 04.20 that morning. The Simranger GSM2 units power off below a 10v DC supply to protect the batteries. Thus, this was deemed the most likely cause of the issue...low battery.

It became apparent that it was only a 30w solar panel on a 7ahr batt and hence was not large enough to sustain both a 4-20ma level and 100ma drain from the Simranger unit.

A 100w solar panel was recommended by Simranger to be fitted with a 24a/hr batt. This was duly obtained from the STW stores back at base on the same day and both solar panel and battery were fitted that same day by the STW instrument technician.
