## **Case Study – GSM2 Comms units**

### **Alport DBS to Ashford DSR mains pressure – GSM Comms Link**

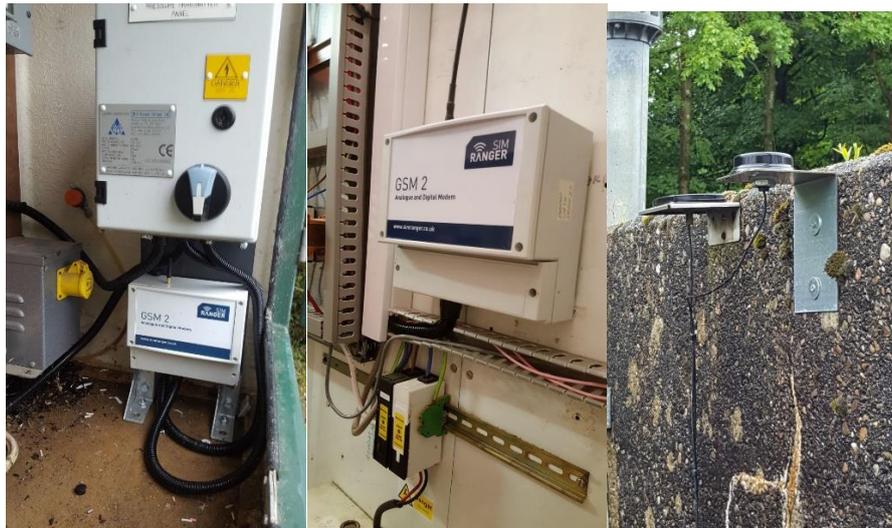
Alport DBS

Ashford DSR

Ashford DSR Aerial

The Simranger GSM2's were fitted via the STW approved contractor in place of the obsolete comms units. This was simply a matter of removing the redundant failed GSM links and replacing with the Simranger GSM2 units and connecting the aerials. The aerial at the Ashford DSR site was required to be mounted on the roof of the underground station to obtain a suitable mobile signal.

Once the units were fitted, taking less than 2 hours for both sites, the units powered up, and comms was swiftly established.
